June 2016 Floods

Submission to:
Government Flood Review Team

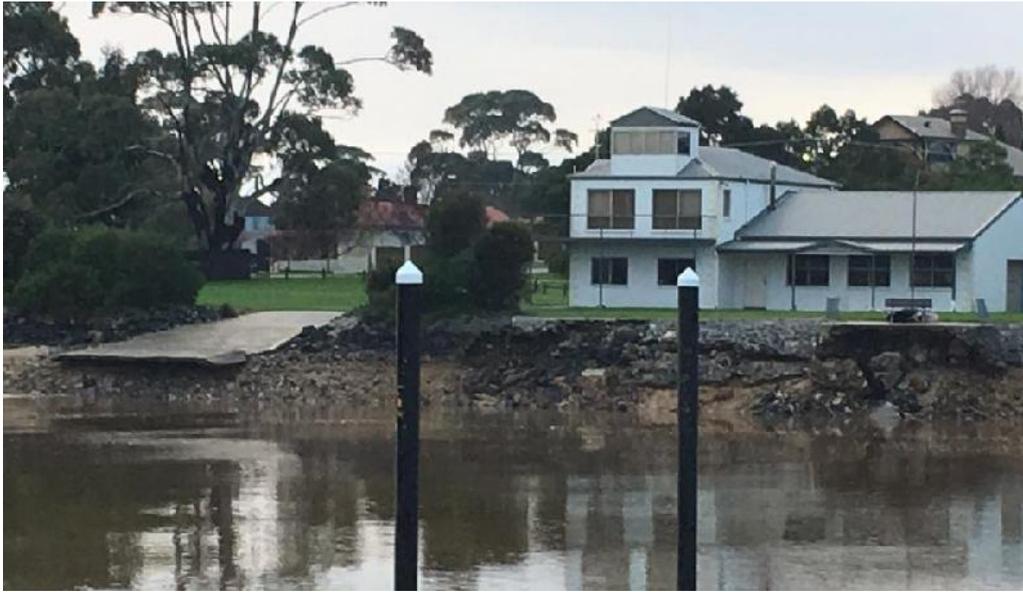
Major damage occurred at the mouth of the Leven River during the flooding with extensive property damage (Leven Yacht Club launching ramps, lookout and associated retaining walls) and the river continuing to move ever so slightly eastwards and now endangering the Clubhouse building. Some of this community infrastructure is being temporarily repaired but no long-term decisions can be made unless and until a full study of the river and its capacity to relocate at the mouth of the river is undertaken.

Leven Yacht Club Infrastructure damage

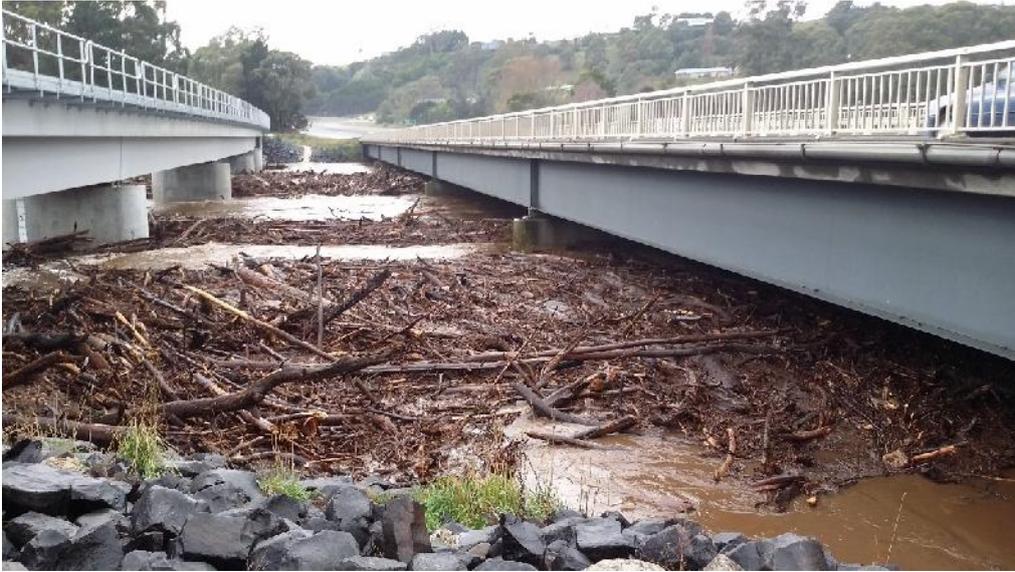
One classic timber dam occurred against and around the pylons of the four Bass Highway and TasRail bridges over the Forth River. Many residents both in nearby Turners Beach and Forth believe that the considerable dam that formed exasperated the flood levels in Forth with photos available of the dams showing a difference of water levels between the upstream and downstream faces of the timber dam having a difference in elevation of between 600mm and 1000mm. Coincidentally this was the increase in flood level in Forth from previous floods. It is acknowledged that the Department of State Growth did attempt to remove the timber during the flooding but the Council has also become aware that TasRail did not agree to a joint effort and that this had a major effect on damming of the flood waters.

Bass Highway Bridges - Log Dam

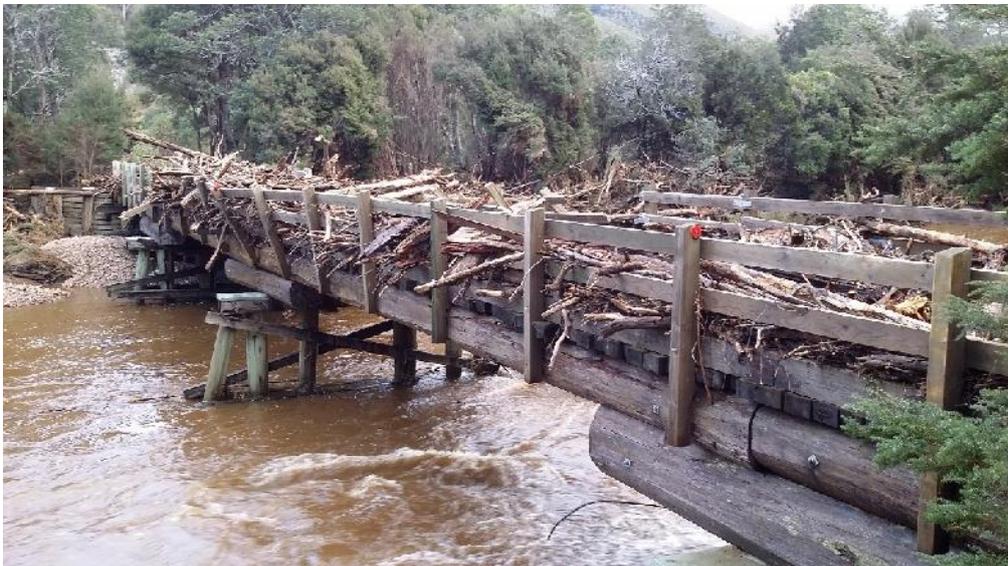
During the floods in the Leven River, two timber bridges suffered severe damage and in one case was totally removed from its location. The bridge at Taylors Flats at Loongana remains in place but has been damaged beyond repair. The timber debris load on the bridge was extreme with the timber measuring over 2m in height.

Timber waste on Taylors Flat bridge after much had been removed as flood waters subsided.

In view of this experience, the Council considers that a more appropriate way of disposal of the timber waste in the coupes needs to be explored and until that is finalised the current practise of leaving waste timber of the forest floor should be modified to at least a major holding area within the coupe where it is prevented from leaving the coupe and entering any nearby streams.

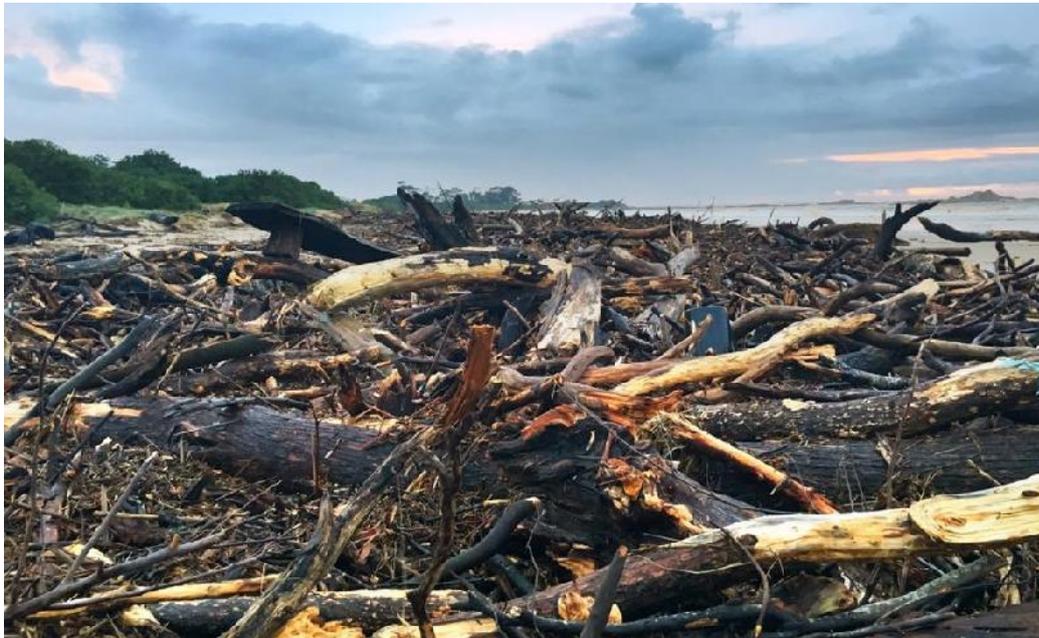
Major debris issues still exist at Turners Beach and Leith Beach and will not be solved by tidal movement. With the coming summer season, these areas are heavily used and now Fire Safety Officers within the Department of Primary Industries, Parks, Water and Environment have suggested that the area has an extreme fire risk as a result of the huge beach debris load adjoining the natural grassy sand dunes fronting the beach. In hindsight, it would have been better to allow substantial timber removal which would have lowered the fire risk considerably.

Turners Beach debris

- (a) The current practises of leaving logging waste in the logged coups be reviewed and modified; and
- (b) State policies relating to removal of timber from beaches and stream be reviewed such that responsible organisations can remove beach and stream debris in order to maintain a suitable level of public safety.

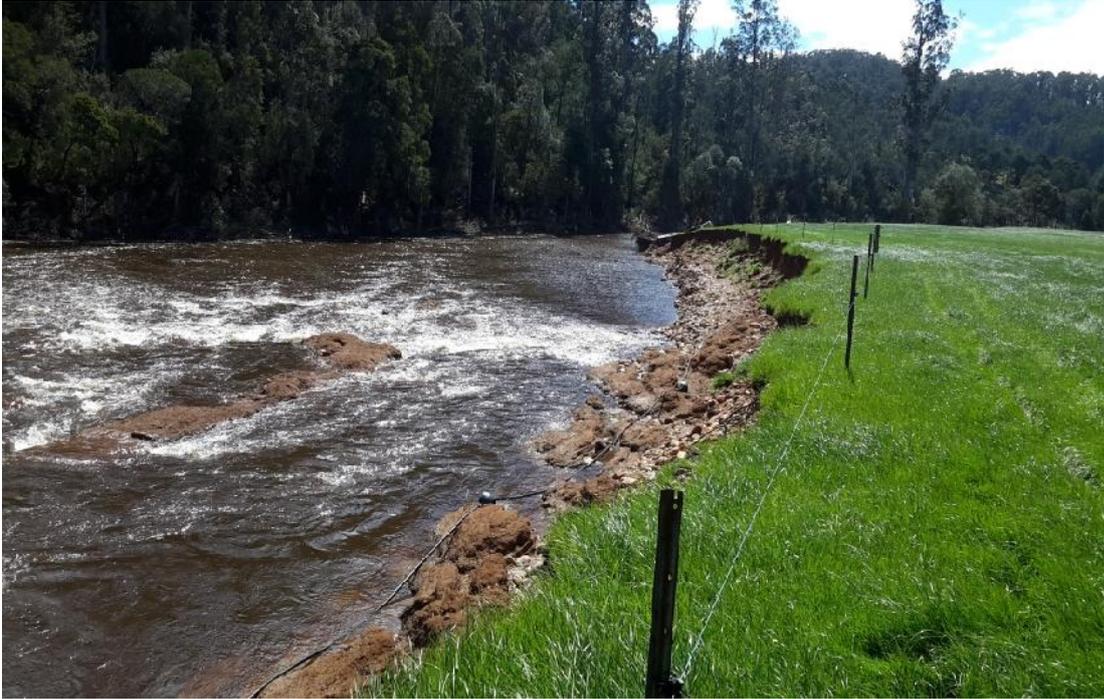
As already outlined elsewhere in this submission, considerable stream bank damage resulted from the flooding with some areas of rivers and creeks being more than twice their normal width. Protection of these fragile stream banks is needed now and out of the ordinary solutions and approvals are required to allow for temporary structures to be placed in streams to protect banks against further damage being caused by the natural flow in the stream. It is respectfully suggested that consideration should be given to allowing temporary training walls in severely damaged areas to stabilise stream banks as well, and farmers should be allowed access to debris mounds in streams to be used for this purpose.

Leven River – bank erosion

- (a) a study of the Leven River is needed as soon as possible to limit the continuing stream damage and to be able to pinpoint pressure points in stream banks,
- (b) relevant Government departments should allow innovative solutions to be used in resolving stream damage and debris build-up
